INDOOR AIR QUALITY ASSESSMENT

Schofield Elementary School 27 Cedar Street Wellesley, Massachusetts

Prepared by:
Massachusetts Department of Public Health
Center for Environmental Health
Bureau of Environmental Health Assessment
Emergency Response/Indoor Air Quality Program
May 2004

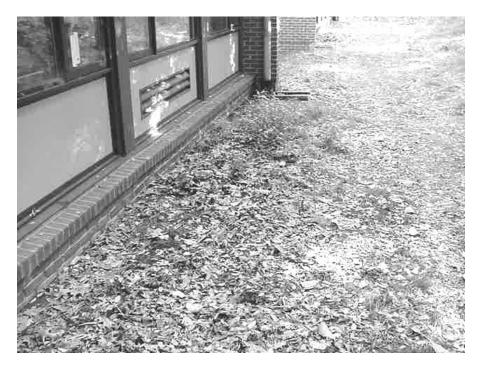
Fresh air in classrooms is supplied by a unit ventilator (univent) system. Univents draw air from outdoors through a fresh air intake located on the exterior walls of the building (Picture 1) and return air through an air intake located at the base of each unit (Figure 1). Fresh and

- Univent fresh air intakes for the 1993 classrooms are located directly above the moistened ground (Picture 1).

Fresh Air Intake on Exterior Wall

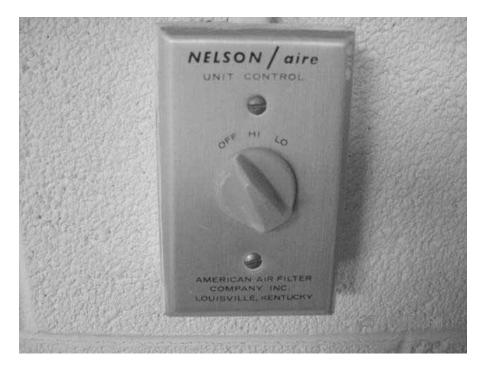
Teachers' Lounge Supply Set To 'Off' Mode

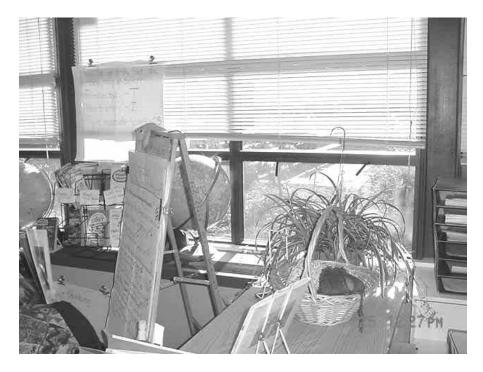
Some plants were found on top of univents, while a container filled with dry soil was found on top of another univent. Plants, soil and drip pans can serve as sources of mold growth, thus should be properly maintained. Over-watering of plants should be avoided and drip pans should

Items On and Around Univent, Note Plant in Close Proximity to Air Diffuser

be inspected periodically for mold growth. Plants should also be located away from univents and ventilation sources to prevent aerosolization of dirt, pollen or mold.

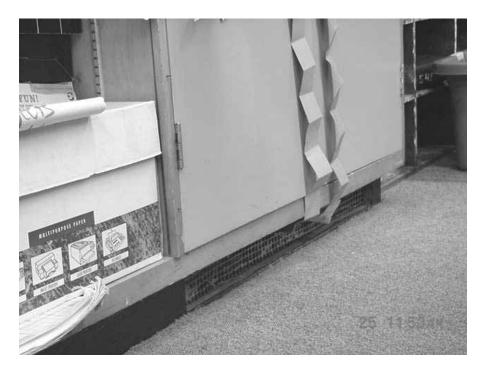
Exhaust ventilation in classrooms is provided by a mechanical system. Exhaust fans are located on the rooftop. In some rooms, air is drawn into exhaust vents located at the base of closets (Picture 4). Many of the closet exhausts were in disrepair. In some cases wooden blocks were used to prop open exhaust louvers to prevent blockage to exhaust ventilation (Picture 5). Louvers should be repaired to ensure proper function of exhaust ventilation. In other classrooms, mechanical exhaust ventilation is provided by wall- or ceiling-mounted exhaust vents. Exhaust vents in some of these rooms were off or drawing weakly. As with univents, in order to function as designed, exhaust vents must remain activated and operating while rooms are occupied. Moreover, the function of these exhausts were hindered by the room design and exhaust vent location. In some classrooms, ceiling-mounted exhaust vents were located above doorways (Picture 6). In such cases, open doors prevent proper functioning of the ceiling-mounted exhaust vents. Rather than exhausting classroom air, these vents draw air from the

Exhaust Ventilation at the Base of Closet

- 10. Consult with an HVAC engineer to discuss repairing/replacing closet exhaust louvers.
- 11. Ensure classroom doors are closed to maintain ceiling-mounted exhaust vent function.

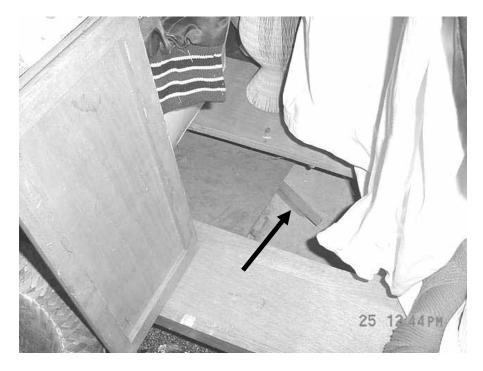
Wooden Block Propping Open an Exhaust Louver

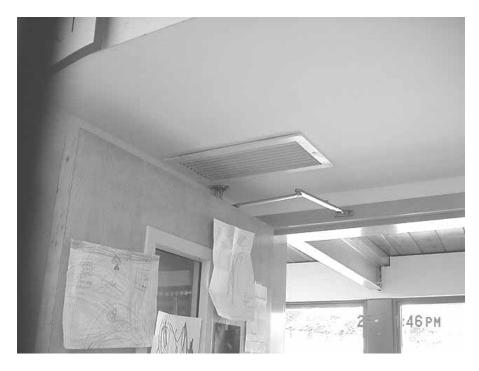
hallway through the open doors. The open hallway door reduces the effectiveness of the exhaust vent to remove common environmental pollutants from classrooms.

Ceiling Mounted Exhaust Vent Located near Doorway

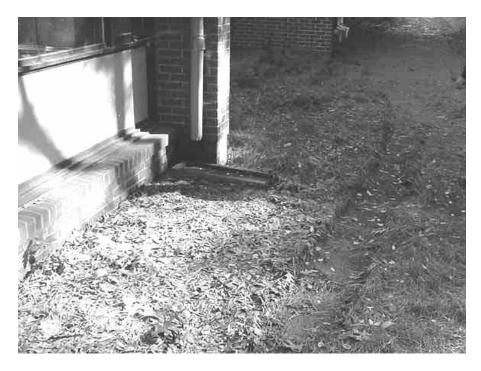
- The 1993 wing is immediately adjacent to a forested area. The trees prevent the sun from drying soil around the exterior wall of the wing.
- The ground at the base of the 1993 wing was covered with leaves and pine needles,
 which prevent the drying of soil. If repeatedly moistened, leaves and pine needles can
 also become mold growth medium (Picture 7).

Downspout Terminating Several Inches above Ground, Note Accumulated Leaves At Base of the Building

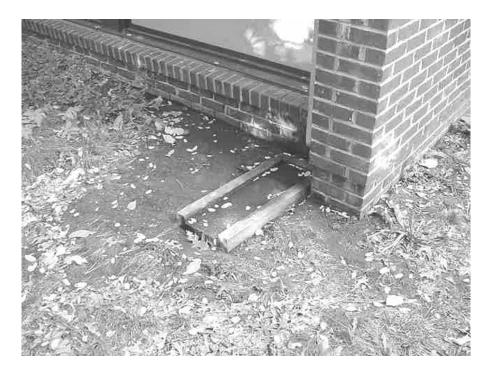
- Cement conduits were installed beneath downspouts to direct water away from the building. Rainwater has compressed the soil beneath the cement conduits, which in some cases have sunk to slope *towards* the building (Picture 8). Chronic exposure to rainwater has resulted in moss growth on the building foundation. Moss can also hold water against the building. Over time, moss growth can result in damage to the slab.

Cement Block Sloped towards Building

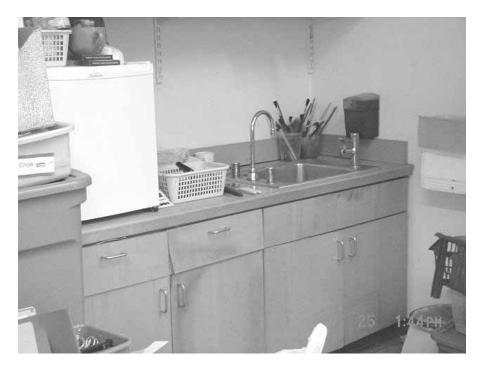
Other sources for water damage were also observed. Open seams between the sink countertop and wall were observed in several rooms (Picture 9). If not watertight, water can penetrate through the seam, causing water damage. In addition, a clapboard drawer was noted to be swelling (Picture 9). A step stool is located in a sink area. The porous material covering the stool was also noted to be water damaged (Picture 10). Water penetration and chronic exposure of porous and wood-based materials can cause these materials to swell and show signs of water damage. As discussed above, moistened materials that are not dried within 24 to 48 hours can become potential sources for mold growth.

Seam between Sink and Countertop Baseboard and Swelling of Drawer Face

- 17. Seal breaches, seams, and spaces between sink countertop and backsplash to prevent water damage.
- 18. Remove plant growths against the exterior wall/foundation of the building to prevent water accumulation.

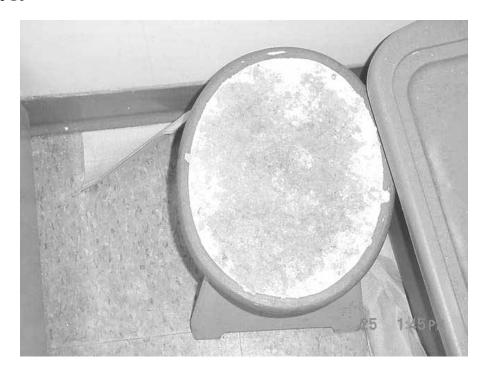
Water Damaged Step Stool

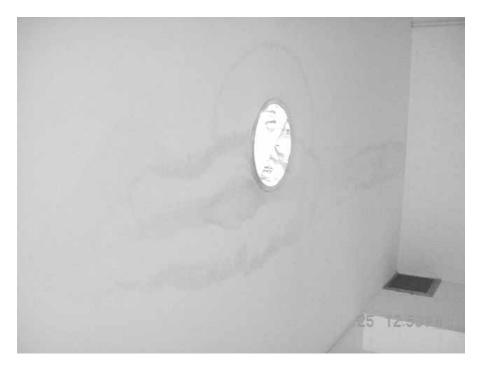
Water damage was also noted on ceiling plaster and wooden ceiling planks in some areas (Pictures 11 and 12). School officials reported that the building has experienced historic roof leaks. A survey of the roof revealed water pooling on most of the roof surfaces (Picture 13). Evergreen trees were growing in close proximity to the building (Picture 14) and tree needles

Water Damaged Ceiling Plaster

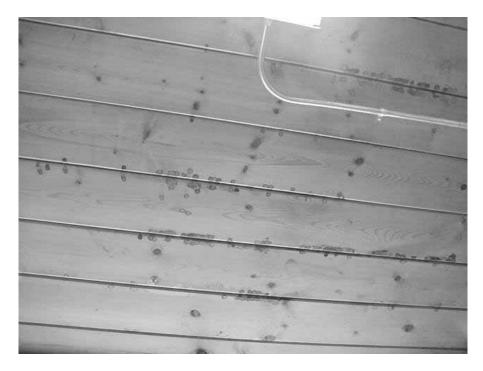
Water Damaged Wooden Ceiling In Gymnasium

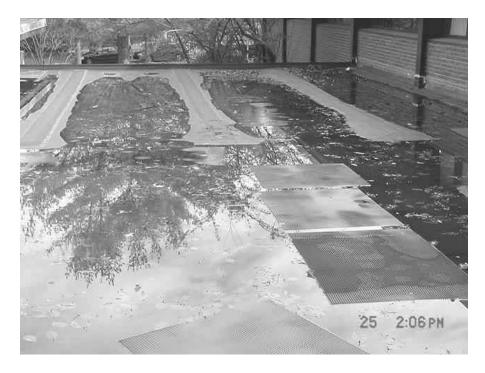
Water Pooling on Rooftop

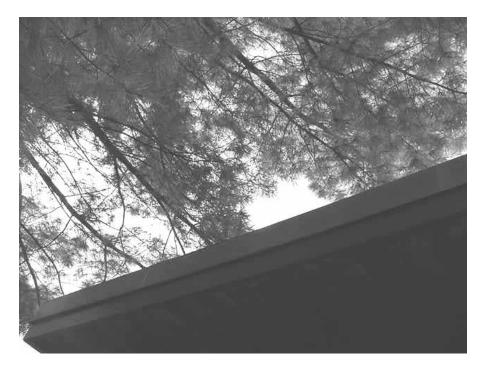
had accumulated around roof drains, creating a dam-like effect that prevented proper drainage of rainwater. Tree needles can hinder the proper function of roof top drains, thereby preventing proper drainage. Freezing and thawing of pooled water can eventually degrade the integrity of the rubber membrane roof, causing cracks to form. These breaches can allow water to penetrate the building.

Evergreen Trees Branching Over School Rooftop

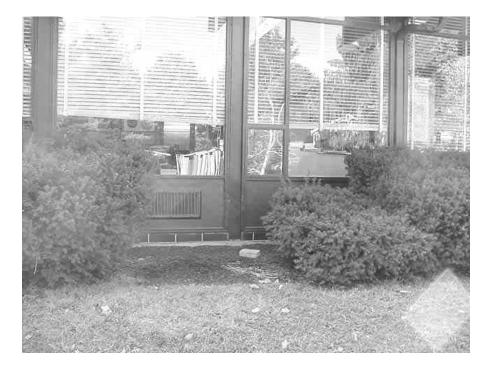
Shrubbery and other plants were growing in close proximity to slab walls (Picture 15). The growth of roots against the exterior walls can bring moisture in contact with wall brick. Plant roots can eventually penetrate the brick, leading to cracks and/or fissures in the foundation below ground level. Over time, this process can undermine the integrity of the building envelope, providing a means of water entry into the building through capillary action through foundation concrete and masonry (Lstiburek & Brennan, 2001).

Shrubbery Growing in Close Proximity to the Building and Fresh Air Intakes

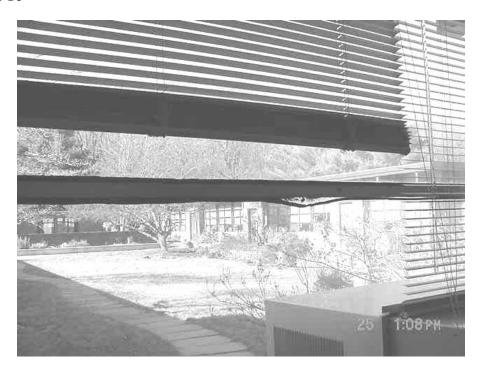
Caulking around windows was missing/damaged in many areas (Picture 16). Missing caulking can make temperature control difficult and allow water to penetrate the building.

Damaged Rubber Gasket around Window

Replacement of caulking and repairs of window leaks are necessary to prevent water penetration and subsequent damage to building materials, which can lead to mold growth.

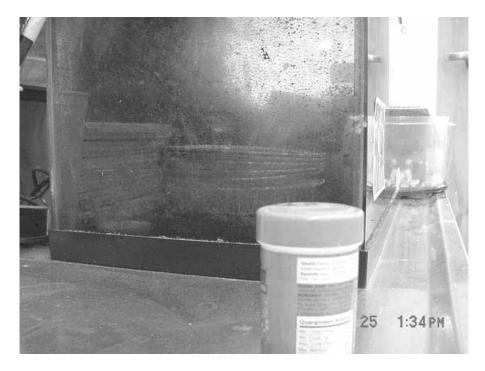
A number of aquariums and terrariums were located in classrooms. Classroom KR contained a fish tank with algae growth (Picture 17). Aquariums should be properly maintained to prevent microbial/algae growth, which can emit unpleasant odors. Similarly, terrariums should be properly maintained to ensure soil does not become a source for mold growth.

Algal Growth in Fish Tank

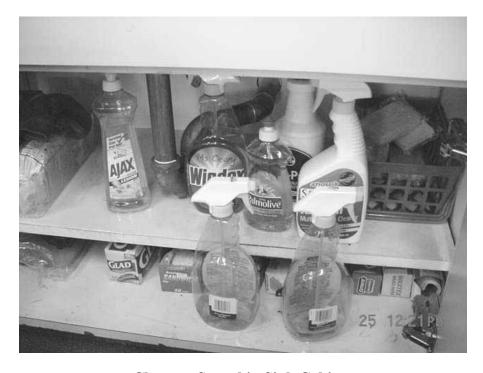
Cleaning products were found on countertops and in unlocked cabinets beneath sinks in some classrooms (Picture 18). Like dry erase materials, cleaning products contain VOCs and other chemicals that can be irritating to the eyes, nose and throat of sensitive individuals. Of particular concern is a spray can of "Vandal Mark Remover", noted on the canister as being extremely flammable and producing vapors that are harmful (Picture 19). Upon discovery, BEHA staff asked Mr. Fogerty to promptly remove the item from the classroom. Also of concern are unlabelled bottles and containers located under sink cabinets. Products should be kept in their original containers or clearly labeled as to their contents for identification purposes, especially in the event of an emergency.

Cleaners Stored in Sink Cabinet

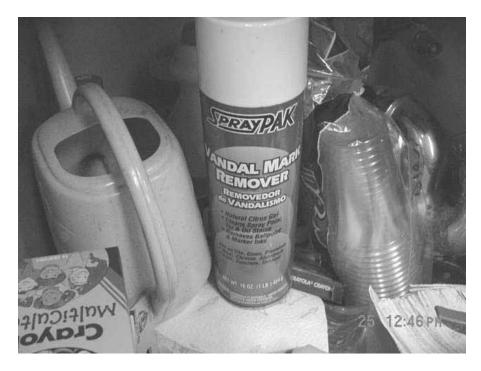
Vandal Mark Remover in Sink Cabinet

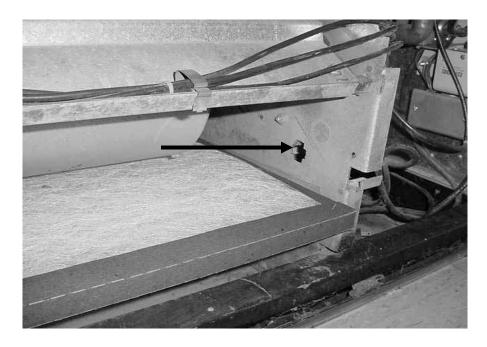
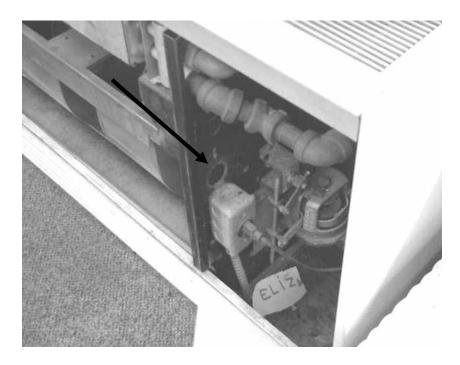
Other conditions that can affect indoor air quality were noted during the assessment. The interiors of several univents were examined. Walls in which univents are installed have spaces and holes within the air handling cabinet (Pictures 20 and 21). Of note is the heavy accumulation of dust around the edges of each hole, indicating unfiltered air passage. The existence of these holes allows for air to by-pass the installed filters, resulting in aerosolization of materials (e.g. dust) from the classrooms. In addition, spaces exist around heating pipes that

Open Holes in Univent Wall Case

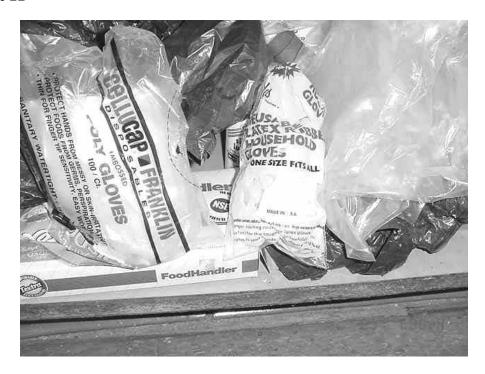
Latex gloves were also found under the cabinet sink (Picture 22). Some individuals are highly allergic to latex (e.g., spina bifida patients) (SBAA, 2001). It is recommended that the use of materials containing latex be limited in buildings to reduce the likelihood of symptoms in sensitive individuals (NIOSH, 1997). A question and answer sheet concerning latex allergy is attached as Appendix B (NIOSH, 1998).

Latex Gloves in Sink Cabinet

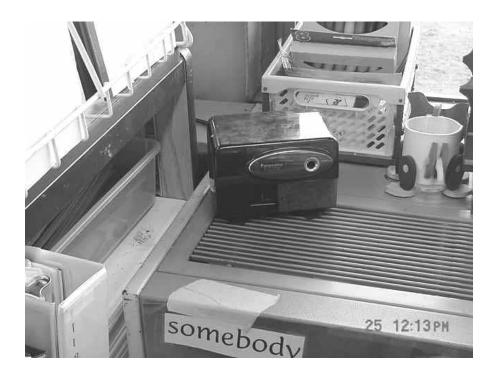
Pencil Sharpener on Univent

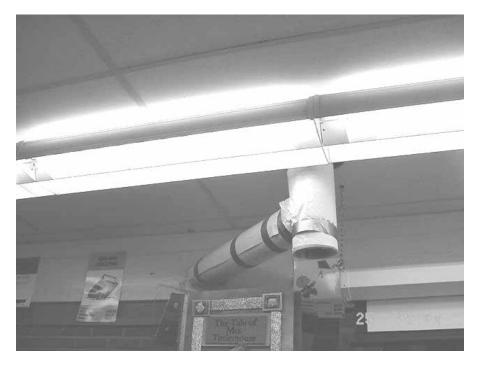
Unwrapped Fiberglass Pipe Insulation

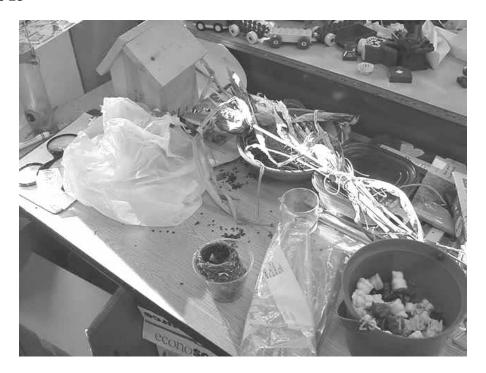
Inactive bird's nests were noted in classrooms and reportedly serve as learning props (Picture 25). Bird's nests can contain bacteria and may also be a source of allergenic material. Nests should be placed in resealable bags to prevent aerosolization of allergenic material. These items should also be located away from univents fresh air diffusers.

Nest in Cup

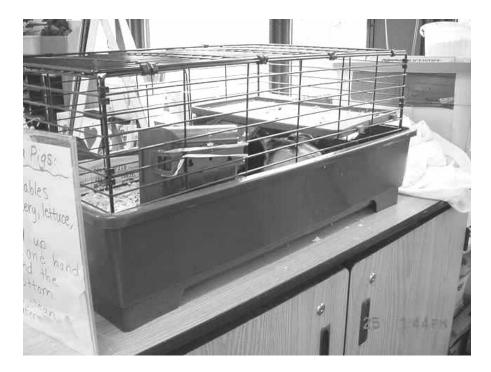
A pet guinea pig was found in one classroom (Picture 26). The cage was lined with wood shavings and had accumulated wastes. Porous materials (i.e., wood shavings) can absorb animal wastes and can be a reservoir for mold and bacterial growth. Animal dander, fur and

Guinea Pig Cage

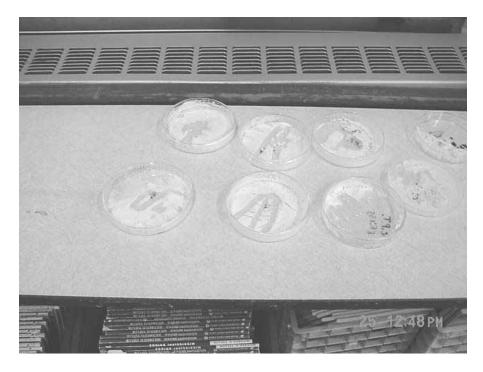
Lastly, food was found in open areas. Many food-based projects were placed uncovered on univents (Pictures 27 and 28). Food is an attractant to pests and rodents. Proper food storage is an integral component in maintaining indoor air quality. Food should be properly stored and clearly labeled. Moreover, food should be placed away from cleaning products, in separate storage areas. Reuse of food containers is not recommended since food residue adhering to the surface may serve to attract pests.

Evaporated Salt Solution near Univent

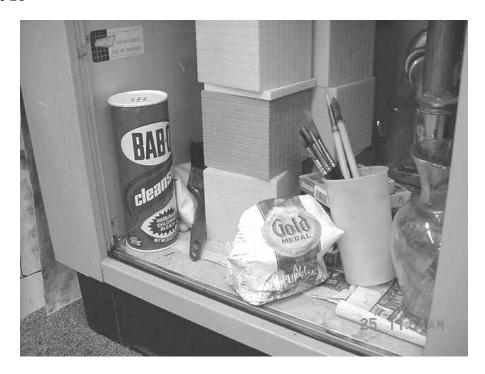
Bleach and Flour In Sink Cabinet
